Risk Assessment of an Existing  
School to the Effects from an  
LPG Vapor Cloud Explosion

Ray W. Anderson  
Agbabian Associates  
Pasadena, California

29 August 1990

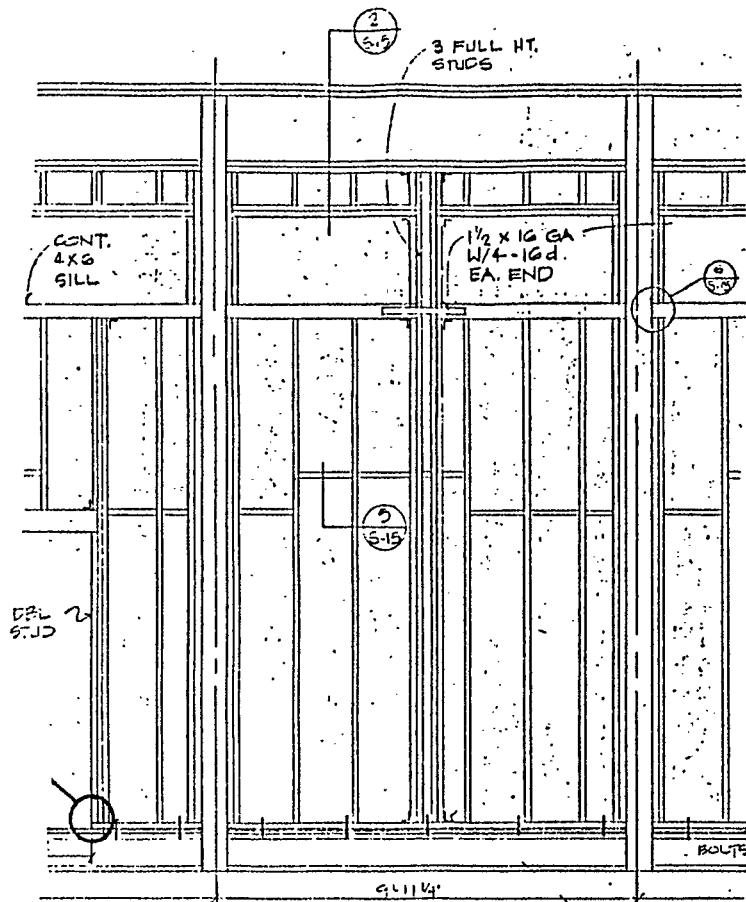
FIGURE 14. MULTIPURPOSE ROOM WALL FRAMING

Wall Framing for the 17-ft High Multipurpose Room: The typical 2 x 6 stud framing (no openings) resistance is at least 0.67 psi. However, the resistance of this continuous framing is limited to 0.46 psi by the bolted wall to steel member connection at the top and bottom, when considering reflected overpressure.

The framing for the north wall is not subjected to reflected overpressures and has a resistance of at least 0.61 psi. However, the south wall framing, because of differences in how the wall is framed for the window openings, is limited by the connection detail used to attach the window sills to the steel module corner columns. This occurs at 9 locations. See Figure 14 for difference in framing for north and south walls. The 1985 Uniform Building Code (UBC), Section 2506(d) and (e), requires that the strength of bolted joints in a wood connection be evaluated not only for the bolt or load but also as a notched beam, considering the notch to extend from unloaded edge of the member to the center of the nearest bolt. This requirement limits the resistance of the wall framing to 0.14 psi. The joint should be reviewed for its adequacy to resist the static design wind load of 15 psf (0.1 psi). In any event, the connection can be strengthened by connecting adjacent window sills with a long steel strap attached to the beams by lag screws. This is required at 9 locations.

The resistance of the multipurpose room is currently limited to 0.13 psi by the bolted connections in wood members framing the south wall that must be treated as notched beams. If these connections are brought up to code, the resistance of the multipurpose room will be at least 0.4 psi. To further increase the resistance of the multipurpose room, the wall bolted connections at top and bottom (resistance of 0.46 psi) and the bottom chord of the roof truss (resistance of 0.37 psi), require strengthening.
